BEFORE PROCEEDING WITH THIS ADJUSTMENT: Contact Cleerline Technical Support at 866-469-2487 to confirm this adjustment is necessary. In many cases cleaving issues are caused by incomplete acrylate removal or incorrect fiber positioning - both of which this adjustment will not resolve. A brief call can save significant time.

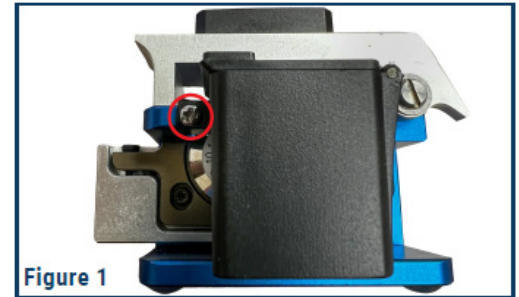
STEP 1 - Remove top phillips screw that holds the trash bin

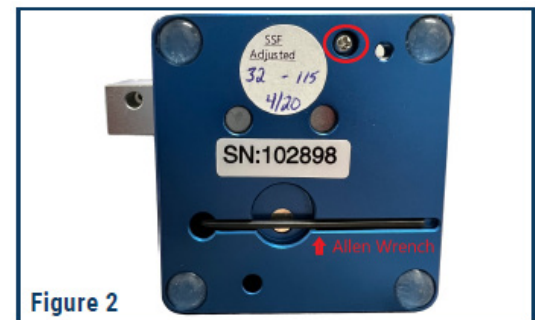
STEP 2 - Remove bottom phillips screw that holds the trash bin

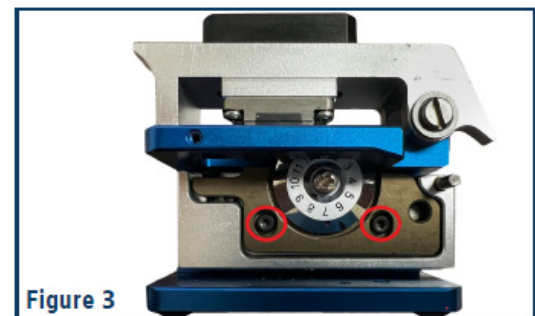
STEP 3 - Use allen wrench located underneath the cleaver (figure 2) to loosen both screws located on the side of the cleaver. Turn both 1 full turn counter-clockwise.

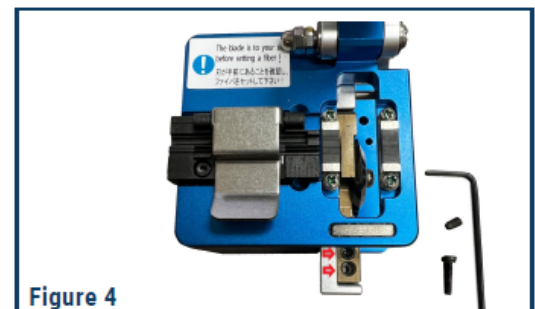
STEP 4 - Locate 2 screws on top of the blade carriage sliding block and use allen wrench to remove both screws completely.

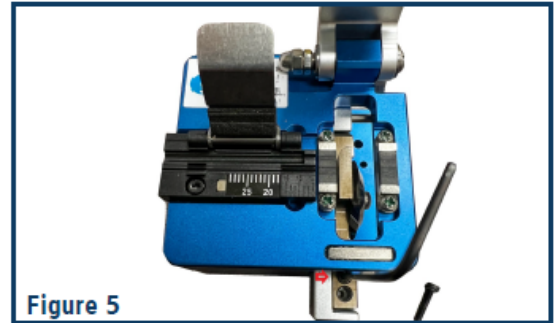
STEP 5 - Re-install small set screw on top of the blade carriage sliding block closest to the wheel & turn 6-3/4 turns clockwise. "DO NOT exceed this number of turns"

- 8a - Loosen both side screws (left & right of blade wheel) 1 full turn counter-clockwise**
- 8b - Loosen longer screw (furthest from wheel) 1 full turn counter-clockwise**
- 8c - Turn small set screw (closest to wheel) clockwise 1/8 turn – do not exceed 1/8 turn per cycle**
- 8d - Re-tighten longer screw until snug**
- 8e - Re-tighten both side screws until snug**
- 8f - Attempt cleave again - repeat 8a through 8f as needed**

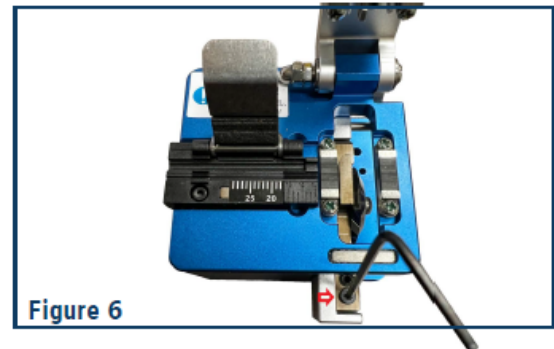
STEP 6 - Re-install longer screw in the opening furthest from the wheel & turn clockwise until snug.

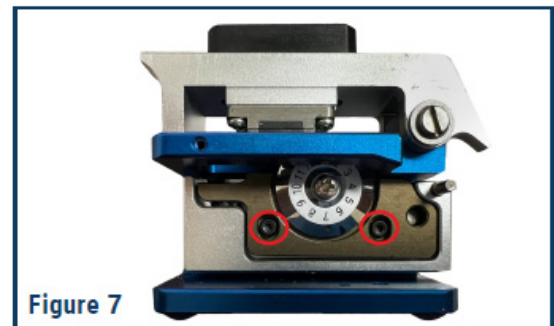
STEP 7 - Turn both screws located left and right of the blade wheel until snug

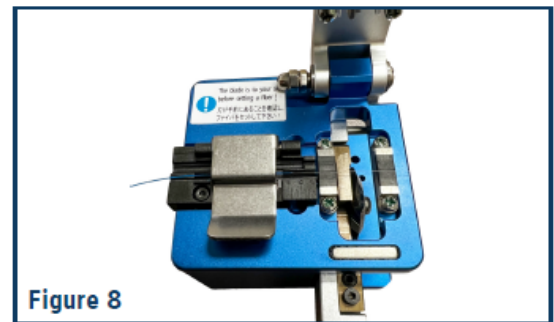
Once fiber has been successfully cleaved 3 times in a row, re-install the trash bin.
